**Flood Control Project Maintenance
Levee Inspections**

Maintenance Issue Types Only, Levee Inspection Report By Mile - Fall 2019

Sutter Maintenance Yard East Levee Sacramento River

Waterway	Bank	Unit Miles	Inspection Start/End	Inspector
Unit No. 01 Sacramento River	Left	19.85	10/16/2019 10/16/2019	Makar Sokol

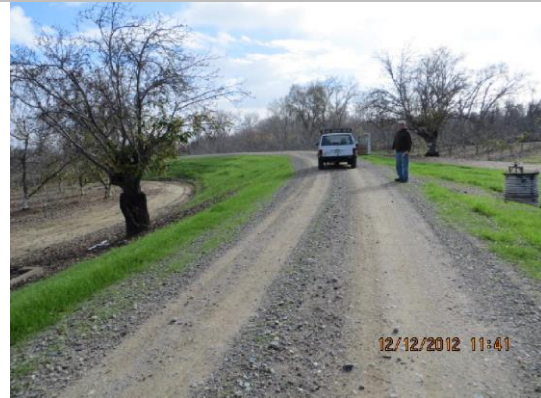
Photo 1 of 3 : UCIP_FA_2019_55547_47202.jpg

Comment Code					
Inspector Comment					
DS_ID:17304 FS_ID:55547 EP_NO: 9529 Repair Type: Non-Urgent Crossing Status: Found UCIP Comments: 07/31/2019 Record remains Non-Urgent; internal inspection found some issues with pipe. Pipe has been abandoned (LS silted in) since 2012. Recommend LMA prepare a contingency plan for increased inspections during high-water to identify any pipe integrity or levee integrity issues that might arise with abandoned pipe. Record will remain in UCIP's list as part of future inspections until the pipe is properly removed or abandoned according to Title 23 requirements. Need to clarify ownership for this crossing. (O. Magana - DWR UCIP)04/19/2017 Abandoned- needs to be done properly. (DWR Sutter Yard- A Freitag)10/31/2016 Abandoned (DWR Sutter Yard- A Freitag)06/01/2016 Abandoned- only WS riser and slide gate found.04/01/2015 CMP riser and slide gate on WS. LS distribution box is silted in. 06/30/2014 Same as last inspection.12/18/2013 Same as last inspection.07/23/2013 Same as last inspection.12/12/2012 Looks abandoned. CMP riser with slide gate on WS. Concrete distribution box on LS- full with silt. (P. Amatya - DWR UCIP) FIELD_STRUCT_DESC: *ABANDONED* 24-inch corrugated metal drainage pipe through the levee, invert 12.8 feet below the crown. Slide gate in a corrugated metal pipe (CMP) riser on the waterside (WS) slope. Concrete box at the landside (LS) toe. (24-inch pipe [HLM 8.35] authorized under Automatic Board Order (ABO) issued as Permit No. 9529, 1974 - Dorwood Ranching Company). [Additional Reference(s): DWR Levee Log, 2002. USACE Sacramento O&M Manual 136, March 1960 (HLM 8.35)]. FS Date: 7/31/2019 8:24:00 AM

Crown view: overview (both sides of the levee)

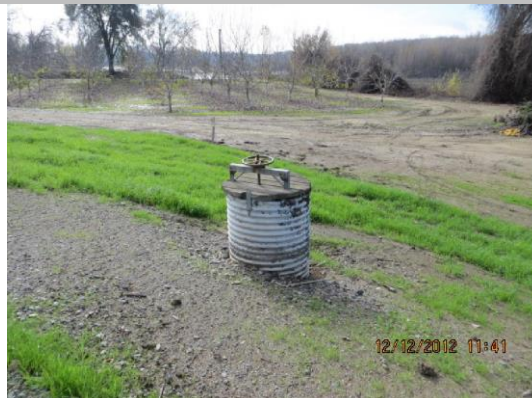
Photo 2 of 3 : UCIP_FA_2019_55547_47201.jpg

Comment Code						
Inspector Comment						
DS_ID:17304 FS_ID:55547 EP_NO: 9529 Repair Type: Non-Urgent Crossing Status: Found UCIP Comments: 07/31/2019 Record remains Non-Urgent; internal inspection found some issues with pipe. Pipe has been abandoned (LS silted in) since 2012. Recommend LMA prepare a contingency plan for increased inspections during high-water to identify any pipe integrity or levee integrity issues that might arise with abandoned pipe. Record will remain in UCIP's list as part of future inspections until the pipe is properly removed or abandoned according to Title 23 requirements. Need to clarify ownership for this crossing. (O. Magana - DWR UCIP)04/19/2017 Abandoned- needs to be done properly. (DWR Sutter Yard- AFreitag)10/31/2016 Abandoned (DWR Sutter Yard-Afreitag)06/01/2016 Abandoned- only WS riser and slide gate found.04/01/2015 CMP riser and slide gate on WS. LS distribution box is silted in. 06/30/2014 Same as last inspection.12/18/2013 Same as last inspection.07/23/2013 Same as last inspection.12/12/2012 Looks abandoned. CMP riser with slide gate on WS. Concrete distribution box on LS- full with silt. (P. Amatya - DWR UCIP) FIELD_STRUCT_DESC: *ABANDONED* 24-inch corrugated metal drainage pipe through the levee, invert 12.8 feet below the crown. Slide gate in a corrugated metal pipe (CMP) riser on the waterside (WS) slope. Concrete box at the landside (LS) toe. (24-inch pipe [HLM 8.35] authorized under Automatic Board Order (ABO) issued as Permit No. 9529, 1974 - Dorwood Ranching Company). [Additional Reference(s): DWR Levee Log, 2002. USACE Sacramento O&M Manual 136, March 1960 (HLM 8.35)]. FS Date: 7/31/2019 8:24:00 AM

WS view: overview of CMP riser

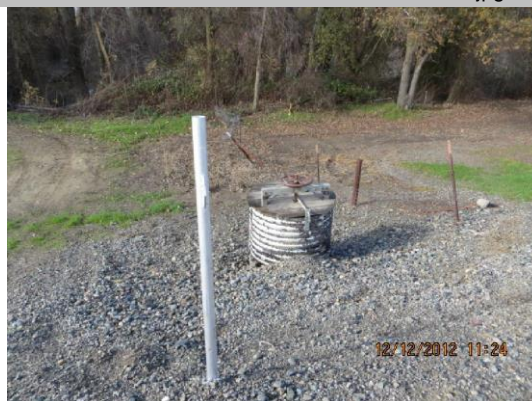
Photo 1 of 3 : UCIP_FA_2019_55550_47208.jpg

DS_ID:17295
FS_ID:55550
EP_NO: 9529
Repair Type: Non-Urgent
Crossing Status: Found
UCIP Comments: 07/31/2019 Record has been updated to from No Action Needed to Non-Urgent; internal inspection found some issues with the pipe. Pipe has been noted as abandoned since 2012. Recommend LMA prepare a contingency plan for increased inspections during high-water to identify any pipe integrity or levee integrity issues that might arise with abandoned pipe. Record will remain in UCIP's list as part of future inspections until the pipe is properly removed or abandoned according to Title 23 requirements. Need to clarify ownership for this crossing. (O. Magana - DWR UCIP)09/21/2017 Permit review indicates this 24-inch pipe was authorized as an irrigation and drainage pipe under ABO issued as Permit No. 9529, structure description was updated. Structure type logged as drainage. (DWR UCIP - O. Magana)
04/19/2017 Abandoned- needs to be done so properly. (DWR Sutter Yard- Afreitag)10/31/2016 Abandoned. (DWR Sutter Yard-Afreitag)06/13/2016 Pipe was exposed and camera inspected by Nor-Cal Pipeline Services 10/29/2015. Photos of the exposed pipe ends were uploaded on 4/1/2015. The internal inspection showed some signs of rust but no visible holes or deterioration were found. After the inspection the pipe ends were capped and reburied.06/09/2016 Khalida Fazel of UCIP requests that any photos of the pipe when it was exposed for a video inspection be kindly uploaded here.04/04/2016 Proper abandonment of pipe is needed. Pipe has been buried again after it was dug up and video inspected, so was not visible on LS. Note that landowner has regraded LS slope so drainage is now to the east (toward LS).04/01/2015 Both WS and LS pipe ends have been dug up in preparation for an internal camera inspection. Pipe shows signs of heavy rust and both ends of pipe are plugged with soil.06/30/2014 Same as last inspection.12/18/2013 Same as last inspection.07/23/2013 Same as last inspection.12/12/2012 Only a CMP riser with slide gate found on WS. (P. Amatya - DWR UCIP) FIELD_STRUCT_DESC: *ABANDONED* 24-inch irrigation and drainage pipe through the levee, invert 11.5 feet below the crown. Slide gate in a corrugated metal pipe (CMP) riser on the waterside (WS) slope. (24-inch pipe [HLM 8.55] authorized under Automatic Board Order (ABO) issued as Permit No. 9529, 1974 - Dorwood Ranching Co.) [Additional Reference(s): DWR Levee Log, 2002. USACE Sacramento O&M Manual 136, March 1960 (HLM 8.55)]

WS view: overview of CMP riser

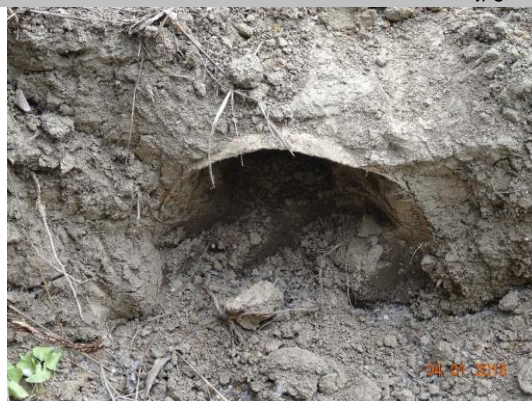
Photo 3 of 3 : UCIP_FA_2019_55550_73640.jpg

DS_ID:17295
FS_ID:55550
EP_NO: 9529
Repair Type: Non-Urgent
Crossing Status: Found
UCIP Comments: 07/31/2019 Record has been updated to from No Action Needed to Non-Urgent; internal inspection found some issues with the pipe. Pipe has been noted as abandoned since 2012. Recommend LMA prepare a contingency plan for increased inspections during high-water to identify any pipe integrity or levee integrity issues that might arise with abandoned pipe. Record will remain in UCIP's list as part of future inspections until the pipe is properly removed or abandoned according to Title 23 requirements. Need to clarify ownership for this crossing. (O. Magana - DWR UCIP)09/21/2017 Permit review indicates this 24-inch pipe was authorized as an irrigation and drainage pipe under ABO issued as Permit No. 9529, structure description was updated. Structure type logged as drainage. (DWR UCIP - O. Magana)
04/19/2017 Abandoned- needs to be done so properly. (DWR Sutter Yard- Afreitag)10/31/2016 Abandoned. (DWR Sutter Yard- Afreitag)06/13/2016 Pipe was exposed and camera inspected by Nor-Cal Pipeline Services 10/29/2015. Photos of the exposed pipe ends were uploaded on 4/1/2015. The internal inspection showed some signs of rust but no visible holes or deterioration were found. After the inspection the pipe ends were capped and reburied.06/09/2016 Khalida Fazel of UCIP requests that any photos of the pipe when it was exposed for a video inspection be kindly uploaded here.04/04/2016 Proper abandonment of pipe is needed. Pipe has been buried again after it was dug up and video inspected, so was not visible on LS. Note that landowner has regraded LS slope so drainage is now to the east (toward LS).04/01/2015 Both WS and LS pipe ends have been dug up in preparation for an internal camera inspection. Pipe shows signs of heavy rust and both ends of pipe are plugged with soil.06/30/2014 Same as last inspection.12/18/2013 Same as last inspection.07/23/2013 Same as last inspection.12/12/2012 Only a CMP riser with slide gate found on WS. (P. Amatya - DWR UCIP) FIELD_STRUCT_DESC: *ABANDONED* 24-inch irrigation and drainage pipe through the levee, invert 11.5 feet below the crown. Slide gate in a corrugated metal pipe (CMP) riser on the waterside (WS) slope. (24-inch pipe [HLM 8.55] authorized under Automatic Board Order (ABO) issued as Permit No. 9529, 1974 - Dorwood Ranching Co.) [Additional Reference(s): DWR Levee Log, 2002. USACE Sacramento O&M Manual 136, March 1960 (HLM 8.55)]

WS pipe end

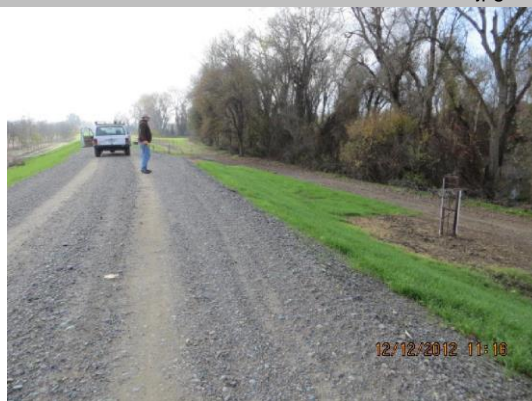
Photo 1 of 3 : UCIP_FA_2019_55552_47210.jpg

DS_ID:17327
FS_ID:55552
EP_NO: 9528
Repair Type: Non-Urgent
Crossing Status: Found
UCIP Comments: 07/31/2019 Record has been updated to Non-Urgent; internal inspection found some issues with the pipe. Pipe has been noted as abandoned since 2012. Recommend LMA prepare a contingency plan for increased inspections during high-water to identify any pipe integrity or levee integrity issues that might arise with abandoned pipe. Record will remain in UCIP's list as part of future inspections until the pipe is properly removed or abandoned according to Title 23 requirements. Need to clarify ownership for this crossing. (O. Magana - DWR UCIP)04/19/2017 Abandoned- needs to be done so properly. (DWR Sutter Yard- Afreitag)10/31/2016 Abandoned. (DWR Sutter Yard- Afreitag)06/13/2016 Pipe was internally cleaned and camera inspected by Nor-Cal Pipeline Services on 10-29-2015. Pipe length through levee is 75.1ft long. The inspection showed some signs of rust but no holes or other deterioration were found. Pics of exposed pipe ends were uploaded on 04/01/2015 After the inspection the pipe ends were capped and reburied.04/14/2016 Same as last inspection.04/01/2015 Both ends of pipe have been dug up in preparation for internal camera inspections. Pipe shows some rust but appears to be in decent shape. 06/30/2014 Same as last inspection.12/18/2013 Same as last inspection.07/23/2013 Same as last inspection.12/12/2012 Only buried slide gate structure found. (P. Amatya - DWR UCIP)

FIELD_STRUCT_DESC: *ABANDONED* 24-inch corrugated metal drainage pipe through the levee, 12.5 feet below the crown. Slide gate on the waterside (WS). (Automatic Board Order (ABO) issued as Permit No. 9528, 1974 - Lamb). [Additional Reference(s): DWR Levee Log, 2002. USACE Sacramento O&M Manual 136, March 1960 (HLM 8.59)].
FS Date: 7/31/2019 10:17:00 AM

WS view: overview

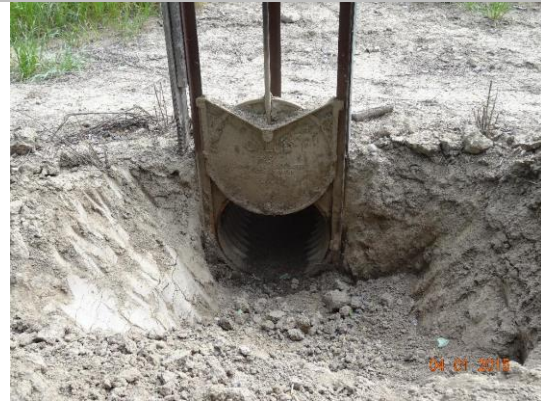
Photo 3 of 3 : UCIP_FA_2019_55552_73649.jpg

Comment Code						
Inspector Comment						
DS_ID:17327 FS_ID:55552 EP_NO: 9528 Repair Type: Non-Urgent Crossing Status: Found UCIP Comments: 07/31/2019 Record has been updated to Non-Urgent; internal inspection found some issues with the pipe. Pipe has been noted as abandoned since 2012. Recommend LMA prepare a contingency plan for increased inspections during high-water to identify any pipe integrity or levee integrity issues that might arise with abandoned pipe. Record will remain in UCIP's list as part of future inspections until the pipe is properly removed or abandoned according to Title 23 requirements. Need to clarify ownership for this crossing. (O. Magana - DWR UCIP)04/19/2017 Abandoned- needs to be done so properly. (DWR Sutter Yard- Afreitag)10/31/2016 Abandoned. (DWR Sutter Yard- Afreitag)06/13/2016 Pipe was internally cleaned and camera inspected by Nor-Cal Pipeline Services on 10-29-2015. Pipe length through levee is 75.1ft long. The inspection showed some signs of rust but no holes or other deterioration were found. Pics of exposed pipe ends were uploaded on 04/01/2015 After the inspection the pipe ends were capped and reburied.04/14/2016 Same as last inspection.04/01/2015 Both ends of pipe have been dug up in preparation for internal camera inspections. Pipe shows some rust but appears to be in decent shape. 06/30/2014 Same as last inspection.12/18/2013 Same as last inspection.07/23/2013 Same as last inspection.12/12/2012 Only buried slide gate structure found. (P. Amatya - DWR UCIP) FIELD_STRUCT_DESC: *ABANDONED* 24-inch corrugated metal drainage pipe through the levee, 12.5 feet below the crown. Slide gate on the waterside (WS). (Automatic Board Order (ABO) issued as Permit No. 9528, 1974 - Lamb). [Additional Reference(s): DWR Levee Log, 2002. USACE Sacramento O&M Manual 136, March 1960 (HLM 8.59)]. FS Date: 7/31/2019 10:17:00 AM

WS pipe end

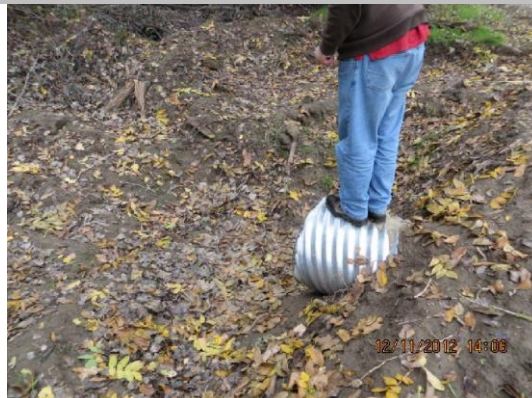
Photo 2 of 3 : UCIP_FA_2019_55554_47241.jpg

DS_ID:17355
FS_ID:55554
EP_NO: N/A
Repair Type: Non-Urgent
Crossing Status: Found
UCIP Comments: 07/31/2019 Record has been updated to Non-Urgent; internal inspection found some issues with pipe. Pipe has been abandoned since 2012 (both inlet/outlet have been covered to avoid soil buildup inside). Record will remain in UCIP's list as part of future inspections until the pipe is properly removed or abandoned according to Title 23 requirements. Need to clarify ownership for this crossing. (O. Magana - DWR UCIP)04/19/2017 Abandoned- needs to be done so properly. (DWR Sutter Yard- Afreitag)10/31/2016 Abandoned. (DWR Sutter Yard- Afreitag)06/13/2016 Pipe was internally cleaned and camera inspected on 10/30/2015 by Nor-Cal Pipeline Services. WS cap was removed and 100.6ft of pipe were inspected starting from the WS opening. Inspection revealed rusting but no visible holes or other deterioration were found. Pipe was recapped after the inspection. This pipe is always visible so no new photos were taken during the inspection.06/09/2016 Khalida Fazel of UCIP requests that any photos of the pipe when it was exposed for a video inspection be kindly uploaded here.04/01/2015 Pipe is in same condition. It has been selected for an internal camera inspection. New 06/30/2014 Same as last inspection.12/18/2013 Same as last inspection.07/23/2013 Same as last inspection.12/11/2012 CMP pipe on WS capped with steel plate. (P. Amatya - DWR UCIP)

FIELD_STRUCT_DESC: *ABANDONED* 24-inch corrugated metal drainage pipe through the levee, 13.5 feet below the crown. Slide gate on the landside (LS) headwall. Steel plate welded on the waterside (WS) end. [Additional Reference(s): DWR Levee Log, 2002. USACE Sacramento O&M Manual 136, March 1960 (HLM 9.4)].
FS Date: 7/31/2019 1:54:00 PM

WS view: overview of CMP pipe

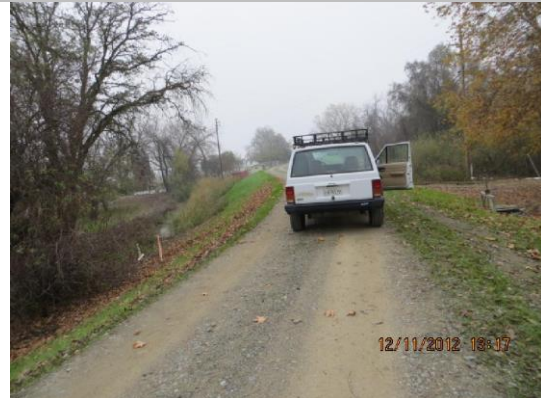
Photo 1 of 3 : UCIP_FA_2019_55558_47263.jpg

Comment Code					
Inspector Comment					
DS_ID:17358 FS_ID:55558 EP_NO: 9517 Repair Type: Non-Urgent Crossing Status: Found UCIP Comments: 07/31/2019 Record has been updated from No Action Needed to Non-Urgent; slide gate handle is still damage and CMP riser lid needs to be repaired. Recommend auditing this record to determine current owner for 48-inch pipe and to obtain maintenance records for ditch and pipes running along LS toe. (O. Magana - DWR UCIP)04/19/2017 No WS end found/ slide gate handle broken. (DWR Sutter Yard- Afreitag)10/31/2016 Slide gate handle is broken and no WS pipe end can be located. (DWR Sutter Yard- Afreitag)06/01/2016 WS slide gate handle is still broken. No WS pipe end was found.04/01/2015 Slide gate handle is still broken. The rest of the pipe appears in good condition. Broken slide gate handle found on WS.06/30/2014 Same as last inspection.12/18/2013 Same as last inspection.07/23/2013 Same as last inspection. FIELD_STRUCT_DESC: 48-inch corrugated metal drainage pipe through the levee, 14 feet below the crown. Slide gate in a 60-inch corrugated metal pipe (CMP) riser on the waterside (WS) slope. Slide gate in a concrete distribution box on the landside (LS) toe. (48-inch pipe [HLM 10.39] authorized under Automatic Board Order (ABO) issued as Permit No. 9517, 1974 - Griffin). [Additional Reference(s): DWR Levee Log, 2002. USACE Sacramento O&M Manual 136, March 1960 (HLM 10.47)]. FS Date: 7/31/2019 1:55:00 PM

Crown view: overview (both sides of the levee)

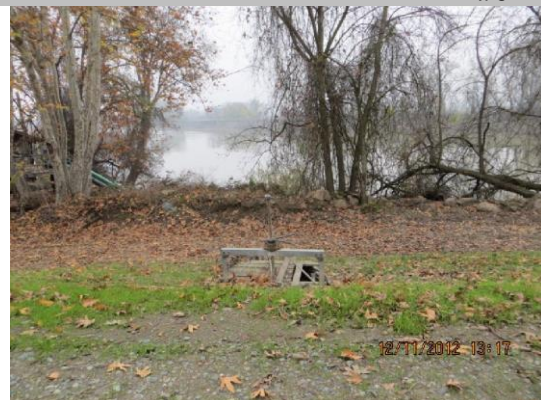
Photo 2 of 3 : UCIP_FA_2019_55558_47262.jpg

WS view: overview of CMP riser

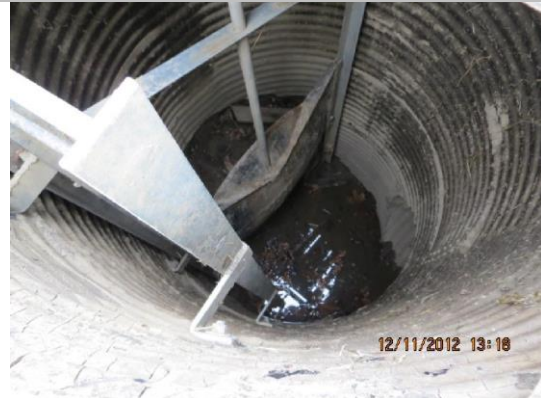
Photo 3 of 3 : UCIP_FA_2019_55558_47268.jpg

Item	DRAFT DWR UCIP LMA Responsibility			39.270492 °	39.270492 °	
				-122.001306 °	-122.001306 °	
DWR ID	17358					
Comment Code						
Inspector Comment						
DS_ID:17358 FS_ID:55558 EP_NO: 9517 Repair Type: Non-Urgent Crossing Status: Found UCIP Comments: 07/31/2019 Record has been updated from No Action Needed to Non-Urgent; slide gate handle is still damage and CMP riser lid needs to be repaired. Recommend auditing this record to determine current owner for 48-inch pipe and to obtain maintenance records for ditch and pipes running along LS toe. (O. Magana - DWR UCIP)04/19/2017 No WS end found/ slide gate handle broken. (DWR Sutter Yard- Afreitag)10/31/2016 Slide gate handle is broken and no WS pipe end can be located. (DWR Sutter Yard- Afreitag)06/01/2016 WS slide gate handle is still broken. No WS pipe end was found.04/01/2015 Slide gate handle is still broken. The rest of the pipe appears in good condition. Broken slide gate handle found on WS.06/30/2014 Same as last inspection.12/18/2013 Same as last inspection.07/23/2013 Same as last inspection. FIELD_STRUCT_DESC: 48-inch corrugated metal drainage pipe through the levee, 14 feet below the crown. Slide gate in a 60-inch corrugated metal pipe (CMP) riser on the waterside (WS) slope. Slide gate in a concrete distribution box on the landside (LS) toe. (48-inch pipe [HLM 10.39] authorized under Automatic Board Order (ABO) issued as Permit No. 9517, 1974 - Griffin). [Additional Reference(s): DWR Levee Log, 2002. USACE Sacramento O&M Manual 136, March 1960 (HLM 10.47)]. FS Date: 7/31/2019 1:55:00 PM

WS view: inside CMP riser

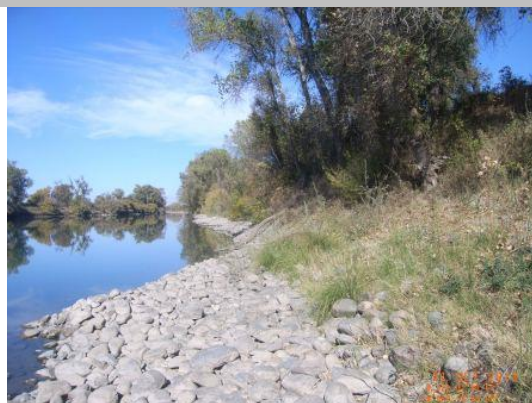
Photo 1 of 1 : FA_2019_ST0003_264_8_20190822_00005.jpg

LM Start	11.53	Rating **	A/W	Issue No.	8
LM End	11.79	Issue Type +	Ma	Location *	WS
Category	Supplemental			GPS Latitude/Longitude	
				Start	End
Item	2017 USACE Erosion Survey			39.279910 °	39.283853 °
				-122.018221 °	-122.016113 °
DWR ID	DWR_ST0003_01_f_2018_8				
Comment Code					
Inspector Comment					
2017 Site ID: SAC 152.6 L					
Status: Eroding					
2017 Field Notes: Access Issues - Could not observe					
Site History: 2008 - Large rotational/mass failure in the bank with tree slump. 2009 - Minimal new erosion, the tree is leaning further into the river. 2011 - Site extended downstream. 2012 - Minor new erosion and tree roots are further exposed.

USACE 2013 Photo #1

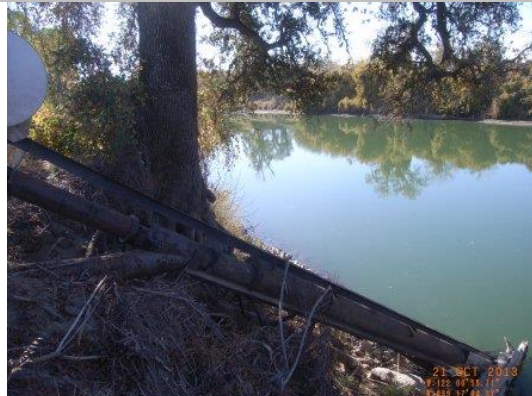
Photo 1 of 1 : FA_2019_ST0003_264_13_20190822_00008.jpg

LM Start	11.85	Rating **	A/W	Issue No.	13
LM End	11.90	Issue Type +	Ma	Location *	WS
Category	Supplemental			GPS Latitude/Longitude	
				Start	End
Item	2017 USACE Erosion Survey			39.284568 °	39.285298 °
				-122.015690 °	-122.015208 °
DWR ID	DWR_ST0003_01_f_2018_13				
Comment Code					
Inspector Comment					
2017 Site ID: SAC 152.8 L					
Status: Eroding					
2017 Field Notes: Minor new erosion observed.					
Site History: 2006 - Large rotational/mass failure in the bank with tree slump. Tough clayey toe material. 2007 - Site is between stone revetments with a pump station at the downstream end. 2010 - Erosion is into the levee toe. 2011 - Minor new erosion. 2012 - Minor new erosion.

USACE 2013 Photo #1

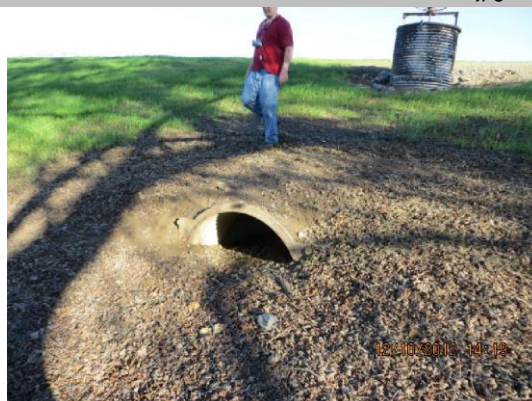
Photo 2 of 3 : UCIP_FA_2019_55576_47342.jpg

DS_ID:17340
FS_ID:55576
EP_NO: 9511
Repair Type: Non-Urgent
Crossing Status: Found
UCIP Comments: 08/01/2019 Crossing remains Non-Urgent; internal inspection shows issues associated with crossing (refer to internal inspection report), pipe has been abandoned, and ABO issued as permit number 9511. Recommend auditing this record to determine current owner and if crossing is no longer in use, the pipe will need to be removed or abandoned per Title 23. Board has been placed on WS outlet to prevent sediment buildup. (O. Magana - DWR UCIP)04/20/2017 Abandoned- needs to be done properly. A oak tree has fallen down onto the WS pipe end. It does not appear to have damaged the pipe but it will need to be better inspected after the tree has been cleared away. (DWR Sutter Yard- AFreitag)10/31/2016 Abandoned. (DWR Sutter Yard- AFreitag)06/14/2016 Pipe was internally cleaned and camera inspected on 11/6/2015 by Nor-Cal Pipeline Services. The 48" cmp pipe section that runs through the levee was deemed to be in good condition. After the LS levee toe the pipe changes to a 48" concrete box culvert for under the roadway and that showed signs of some cracking. After the inspection the WS end was capped to keep sediment out until further abandonment can be achieved.04/16/2016 A wooden board has been placed on WS outlet of pipe to prevent sediment from entering pipe. This is a temporary repair measure by Sutter Yard until pipe can be grouted. Need to contact owner to ensure pipe's proper abandonment. Blockage of pipe outlet by wooden board or sediment will pose a hazard during high water. Pipe owner unclear, as landowner differs on LS and WS.04/02/2015 Pipe has been selected for internal camera inspection.Outlet pipe silted on WS. Inlet structure damaged on LS. Not properly abandoned.07/02/2014 Same as last inspection.12/19/2013 Same as last inspection.07/23/2013 Same as last inspection.

FIELD_STRUCT_DESC: *ABANDONED* 48-inch corrugated metal drainage pipe through the levee, 16.5 feet below the crown. Slide gate in a 60-inch corrugated metal pipe (CMP) riser on the waterside (WS) slope. Landside (LS) end of pipe on east side of River Road. Pipe is not in use but is operable. (48-inch pipe [HLM 13.37] authorized under Permit No. 9511, 1974 - Moresco). [Additional Reference(s): DWR Levee Log, 2002. USACE Sacramento O&M Manual 136, March 1960 (HLM 13.37)].
FS Date: 8/1/2019 1:50:00 PM

WS view: overview of CMP riser and outlet pipe

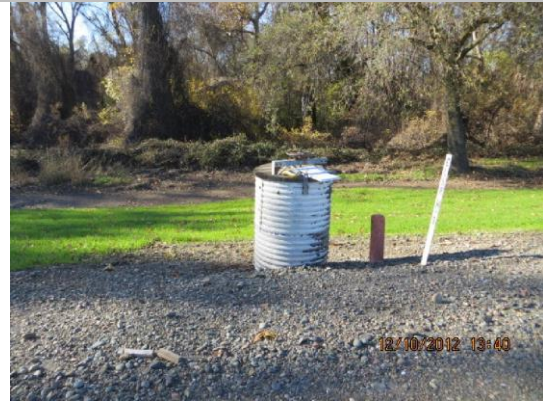
Photo 1 of 3 : UCIP_FA_2019_55579_47356.jpg

Comment Code					
Inspector Comment					
DS_ID:17330 FS_ID:55579 EP_NO: 9508 Repair Type: Non-Urgent Crossing Status: Found UCIP Comments: 08/01/2019 Crossing has been updated from No Action Need to Non-Urgent, crossing has been abandoned. The WS pipe end has not been found. Recommend auditing this record to confirm current owner associated with ABO issued as permit number 9508. (O. Magana - DWR UCIP)04/20/2017 Abandoned- needs to be done so properly. (DWR Sutter Yard- AFreitag)10/31/2016 Appears abandoned. WS pipe end buried. (DWR Sutter Yard- AFreitag)06/14/2016 Pipe was internally cleaned and camera inspected on 11/17/2015 by Nor-Cal Pipeline Services. Pipe section through levee is 86ft long and showed some signs of rusting but no visible holes or other deterioration was found. After the inspection the WS end was capped and reburied until further abandonment can be achieved.04/14/2016 Concrete box on LS cleared of sediment.04/02/2015 Same as last inspection. Concrete box on LS silted in. If abandoned it should be done so properly.07/02/2014 Same as last inspection.12/19/2013 Same as last inspection.07/23/2013 Same as last inspection. FIELD_STRUCT_DESC: 24-inch corrugated metal drainage pipe through the levee, 14 feet below the crown. Slide gate in a 36-inch corrugated metal pipe (CMP) riser on the waterside (WS) slope. Concrete distribution box on the landside (LS). (24-inch pipe [HLM 14.5] authorized under Automatic Board Order (ABO) issued as Permit No. 9508, 1974 - Jones). [Additional Reference(s): DWR Levee Log, 2002. USACE Sacramento O&M Manual 136, March 1960 (HLM 14.5)]. FS Date: 8/1/2019 1:52:00 PM

WS view: CMP riser with slide gate

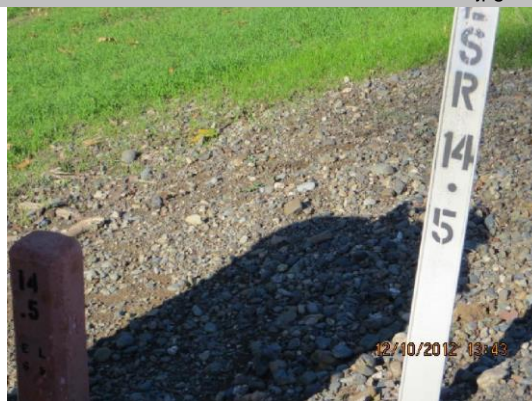
Photo 2 of 3 : UCIP_FA_2019_55579_47361.jpg

DS_ID:17330
 FS_ID:55579
 EP_NO: 9508
 Repair Type: Non-Urgent
 Crossing Status: Found
 UCIP Comments: 08/01/2019 Crossing has been updated from No Action Need to Non-Urgent, crossing has been abandoned. The WS pipe end has not been found. Recommend auditing this record to confirm current owner associated with ABO issued as permit number 9508. (O. Magana - DWR UCIP)04/20/2017 Abandoned- needs to be done so properly. (DWR Sutter Yard- AFreitag)10/31/2016 Appears abandoned. WS pipe end buried. (DWR Sutter Yard- AFreitag)06/14/2016 Pipe was internally cleaned and camera inspected on 11/17/2015 by Nor-Cal Pipeline Services. Pipe section through levee is 86ft long and showed some signs of rusting but no visible holes or other deterioration was found. After the inspection the WS end was capped and reburied until further abandonment can be achieved.04/14/2016 Concrete box on LS cleared of sediment.04/02/2015 Same as last inspection. Concrete box on LS silted in. If abandoned it should be done so properly.07/02/2014 Same as last inspection.12/19/2013 Same as last inspection.07/23/2013 Same as last inspection.

FIELD_STRUCT_DESC: 24-inch corrugated metal drainage pipe through the levee, 14 feet below the crown. Slide gate in a 36-inch corrugated metal pipe (CMP) riser on the waterside (WS) slope. Concrete distribution box on the landside (LS). (24-inch pipe [HLM 14.5] authorized under Automatic Board Order (ABO) issued as Permit No. 9508, 1974 - Jones). [Additional Reference(s): DWR Levee Log, 2002. USACE Sacramento O&M Manual 136, March 1960 (HLM 14.5)].
 FS Date: 8/1/2019 1:52:00 PM

WS view: levee mile marker

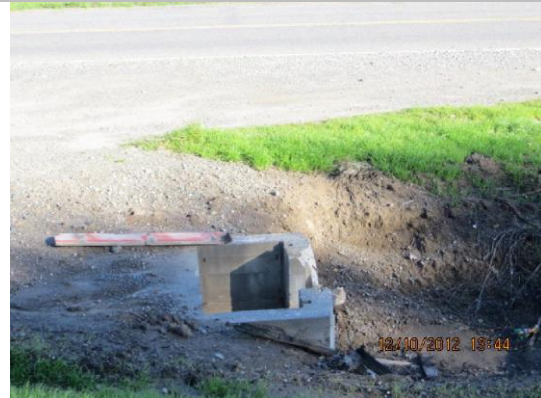
Photo 3 of 3 : UCIP_FA_2019_55579_47360.jpg

Item	DRAFT DWR UCIP LMA Responsibility			39.321429°	39.321429°	
				-122.016079°	-122.016079°	
DWR ID	17330					
Comment Code						
Inspector Comment						
DS_ID:17330 FS_ID:55579 EP_NO: 9508 Repair Type: Non-Urgent Crossing Status: Found UCIP Comments: 08/01/2019 Crossing has been updated from No Action Need to Non-Urgent, crossing has been abandoned. The WS pipe end has not been found. Recommend auditing this record to confirm current owner associated with ABO issued as permit number 9508. (O. Magana - DWR UCIP)04/20/2017 Abandoned- needs to be done so properly. (DWR Sutter Yard- AFreitag)10/31/2016 Appears abandoned. WS pipe end buried. (DWR Sutter Yard- AFreitag)06/14/2016 Pipe was internally cleaned and camera inspected on 11/17/2015 by Nor-Cal Pipeline Services. Pipe section through levee is 86ft long and showed some signs of rusting but no visible holes or other deterioration was found. After the inspection the WS end was capped and reburied until further abandonment can be achieved.04/14/2016 Concrete box on LS cleared of sediment.04/02/2015 Same as last inspection. Concrete box on LS silted in. If abandoned it should be done so properly.07/02/2014 Same as last inspection.12/19/2013 Same as last inspection.07/23/2013 Same as last inspection. FIELD_STRUCT_DESC: 24-inch corrugated metal drainage pipe through the levee, 14 feet below the crown. Slide gate in a 36-inch corrugated metal pipe (CMP) riser on the waterside (WS) slope. Concrete distribution box on the landside (LS). (24-inch pipe [HLM 14.5] authorized under Automatic Board Order (ABO) issued as Permit No. 9508, 1974 - Jones). [Additional Reference(s): DWR Levee Log, 2002. USACE Sacramento O&M Manual 136, March 1960 (HLM 14.5)]. FS Date: 8/1/2019 1:52:00 PM

LS view: overview of distribution box

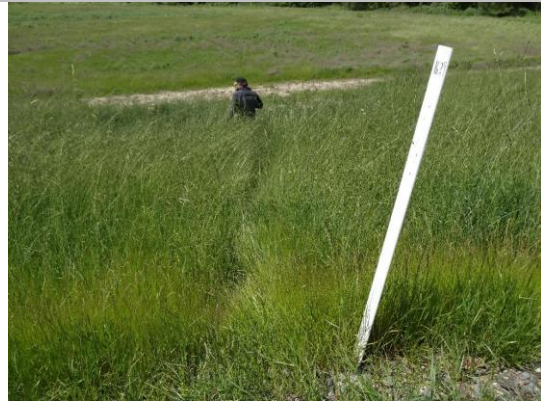
Photo 1 of 3 : UCIP_FA_2019_55591_75096.jpg

View from crown down WS slope at location of crossing.

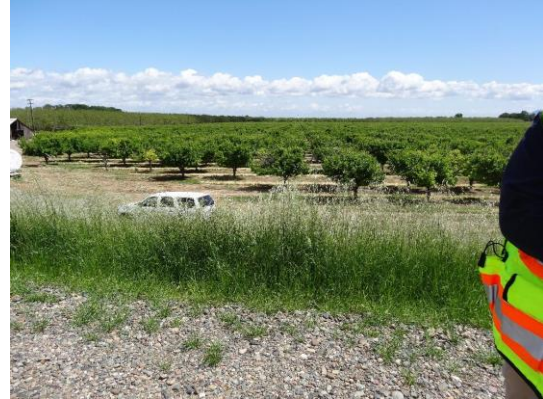
Photo 2 of 3 : UCIP_FA_2019_55591_75097.jpg

View of LS from crown at location of crossing.

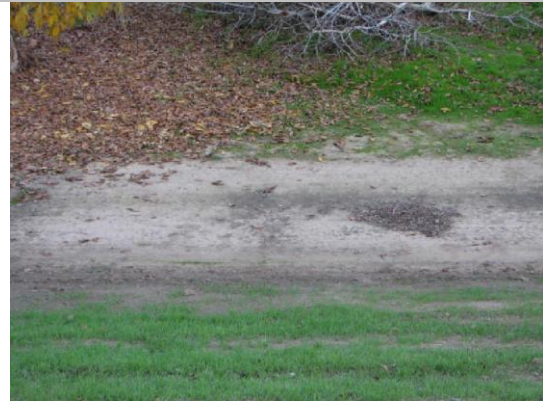
Photo 1 of 3 : UCIP_FA_2019_55599_47384.jpg

Comment Code					
Inspector Comment					
DS_ID:17329 FS_ID:55599 EP_NO: N/A Repair Type: Urgent Crossing Status: Found UCIP Comments: 08/05/2019 Crossing has been updated from Non-Urgent to Urgent due to leak observed in 2017 during high water. The appears to be a leak that could be caused by the screw gate not fully closed allowing water from the WS to LS. No permit has been found authorizing the crossing. If crossing is no longer in use, owner will need to remove or abandon properly per Title 23 requirements. Slide gate width measures 36 inches and not the 24 inches that is needed for the 24-inch pipe. (O. Magana - DWR UCIP)04/20/2017 Abandoned-needs to be done properly. Pipe had a small leak during high water and is believed to be caused by the screw gate not being fully closed before it was reburied after its internal inspection. (DWR Sutter Yard-AFreitag)11/01/2016 Abandoned. (DWR Sutter Yard-AFreitag)06/15/2016 Pipe was dug up and internally cleaned and camera inspected on 11/18/2015 by Nor-Cal Pipeline Services. Pipe section through levee is about 93.8ft long. Inspection showed signs of rusting but no holes or other deterioration was found. WS end and slide gate were photographed, LS end was not. After the inspection pipe ends were capped and reburied until further abandonment can be achieved.04/02/2015 WS pipe end was dug up in preparation for internal camera inspection. Only steel slide gate structure found on waterside.07/02/2014 Same as last inspection.12/19/2013 Same as last inspection.07/24/2013 Same as last inspection. FIELD_STRUCT_DESC: *ABANDONED* 24-inch corrugated metal drainage pipe through the levee, 15.8 feet below the crown. Slide gate on the waterside (WS) end. Both pipe ends are silted over. [Additional Reference(s): DWR Levee Log, 2002. USACE Sacramento O&M Manual 136, March 1960 (HLM 17.6)]. FS Date: 8/5/2019 2:29:00 PM

LS view: overview. No pipe found.

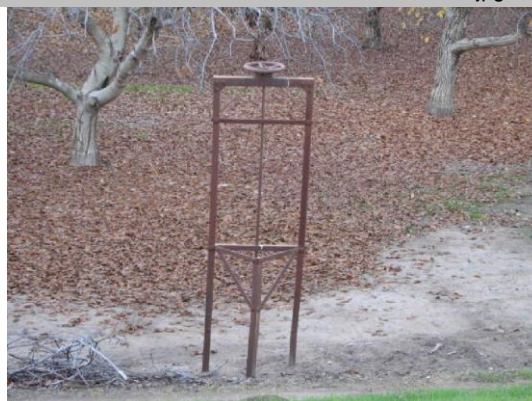
Photo 2 of 3 : UCIP_FA_2019_55599_47386.jpg

Item	DRAFT DWR UCIP LMA Responsibility			39.353531 °	39.353531 °	
				-122.009138 °	-122.009138 °	
DWR ID	17329					
Comment Code						
Inspector Comment						
DS_ID:17329 FS_ID:55599 EP_NO: N/A Repair Type: Urgent Crossing Status: Found UCIP Comments: 08/05/2019 Crossing has been updated from Non-Urgent to Urgent due to leak observed in 2017 during high water. The appears to be a leak that could be caused by the screw gate not fully closed allowing water from the WS to LS. No permit has been found authorizing the crossing. If crossing is no longer in use, owner will need to remove or abandon properly per Title 23 requirements. Slide gate width measures 36 inches and not the 24 inches that is needed for the 24-inch pipe. (O. Magana - DWR UCIP)04/20/2017 Abandoned-needs to be done properly. Pipe had a small leak during high water and is believed to be caused by the screw gate not being fully closed before it was reburied after its internal inspection. (DWR Sutter Yard-AFreitag)11/01/2016 Abandoned. (DWR Sutter Yard-AFreitag)06/15/2016 Pipe was dug up and internally cleaned and camera inspected on 11/18/2015 by Nor-Cal Pipeline Services. Pipe section through levee is about 93.8ft long. Inspection showed signs of rusting but no holes or other deterioration was found. WS end and slide gate were photographed, LS end was not. After the inspection pipe ends were capped and reburied until further abandonment can be achieved.04/02/2015 WS pipe end was dug up in preparation for internal camera inspection. Only steel slide gate structure found on waterside.07/02/2014 Same as last inspection.12/19/2013 Same as last inspection.07/24/2013 Same as last inspection. FIELD_STRUCT_DESC: *ABANDONED* 24-inch corrugated metal drainage pipe through the levee, 15.8 feet below the crown. Slide gate on the waterside (WS) end. Both pipe ends are silted over. [Additional Reference(s): DWR Levee Log, 2002. USACE Sacramento O&M Manual 136, March 1960 (HLM 17.6)]. FS Date: 8/5/2019 2:29:00 PM

WS view: slide gate steel structure

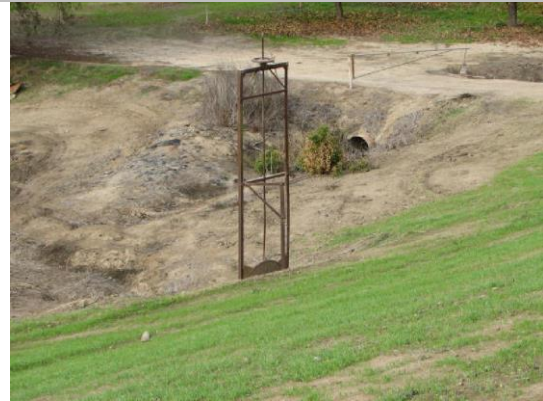
Photo 1 of 3 : UCIP_FA_2019_55610_47399.jpg

Comment Code					
Inspector Comment					
DS_ID:17345 FS_ID:55610 EP_NO: N/A Repair Type: Non-Urgent Crossing Status: Found UCIP Comments: 08/05/2019 Crossing has been upgraded from No Action Needed to Non-Urgent; no permit has been identified for this crossing. Need to contact owner to determine primary use of pipe through the levee. Need to establish who own this crossing. (O. Magana - DWR UCIP)04/20/2017 Crossing appears to be in good condition. (DWR Sutter Yard- A Freitag)11/01/2016 Crossing appears to be in good condition. (DWR Sutter Yard- A Freitag)06/16/2016 Pipe was internally cleaned and camera inspected on 11/19/2015 by Nor-Cal Pipeline Services. Pipe is 155ft in total length and the inspection showed some minor rusting but no holes or other deformations were found. Pipe is still used by the landowner for irrigation and the sloughing near the WS end was repaired and rocked to prevent future sloughing or erosion.04/14/2016 Sloughing repaired by Sutter Yard with rock revetment.04/02/2015 Same as last inspection. Pipe has been selected for internal camera inspection.Sloughing at outlet and levee slope is damaged due to sloughing.07/02/2014 It is not an abandoned crossing. Sloughing at outlet and levee slope is damaged due to sloughing.12/19/2013 Same as last inspection.07/24/2013 Same as last inspection. FIELD_STRUCT_DESC: 36-inch corrugated metal drainage pipe through the levee, 20 feet below the crown. Slide gate at the waterside (WS) toe. [Additional Reference(s): DWR Levee Log, 2002. USACE Sacramento O&M Manual 136, March 1960 (HLM 18.65)]. FS Date: 8/5/2019 2:43:00 PM

WS view: overview of sliding gate structure

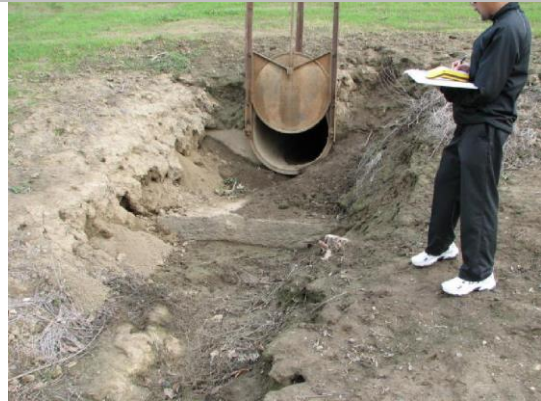
Photo 2 of 3 : UCIP_FA_2019_55610_47398.jpg

Item	DRAFT DWR UCIP LMA Responsibility			39.362866 °		39.362866 °
				-121.997993 °		-121.997993 °
DWR ID	17345					
Comment Code						
Inspector Comment						
DS_ID:17345 FS_ID:55610 EP_NO: N/A Repair Type: Non-Urgent Crossing Status: Found UCIP Comments: 08/05/2019 Crossing has been upgraded from No Action Needed to Non-Urgent; no permit has been identified for this crossing. Need to contact owner to determine primary use of pipe through the levee. Need to establish who own this crossing. (O. Magana - DWR UCIP)04/20/2017 Crossing appears to be in good condition. (DWR Sutter Yard- A Freitag)11/01/2016 Crossing appears to be in good condition. (DWR Sutter Yard- A Freitag)06/16/2016 Pipe was internally cleaned and camera inspected on 11/19/2015 by Nor-Cal Pipeline Services. Pipe is 155ft in total length and the inspection showed some minor rusting but no holes or other deformations were found. Pipe is still used by the landowner for irrigation and the sloughing near the WS end was repaired and rocked to prevent future sloughing or erosion.04/14/2016 Sloughing repaired by Sutter Yard with rock revetment.04/02/2015 Same as last inspection. Pipe has been selected for internal camera inspection.Sloughing at outlet and levee slope is damaged due to sloughing.07/02/2014 It is not an abandoned crossing. Sloughing at outlet and levee slope is damaged due to sloughing.12/19/2013 Same as last inspection.07/24/2013 Same as last inspection. FIELD_STRUCT_DESC: 36-inch corrugated metal drainage pipe through the levee, 20 feet below the crown. Slide gate at the waterside (WS) toe. [Additional Reference(s): DWR Levee Log, 2002. USACE Sacramento O&M Manual 136, March 1960 (HLM 18.65)]. FS Date: 8/5/2019 2:43:00 PM

WS view: outlet pipe with concrete headwall and floor apron.

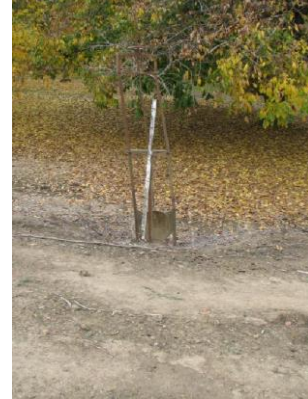
Photo 1 of 3 : UCIP_FA_2019_55611_47442.jpg

Item	DRAFT DWR UCIP LMA Responsibility		39.364067 °	39.364067 °								
			-121.997792 °	-121.997792 °								
DWR ID	17346											
Comment Code												
Inspector Comment												
DS_ID:17346 FS_ID:55611 EP_NO: 9503 Repair Type: Non-Urgent Crossing Status: Found UCIP Comments: 08/05/2019 Crossing has been updated from No Action Needed to Non-Urgent, pipe has been modified from original use. An 8-inch pipe has been sleeved through the 24-inch pipe and gap between pipes pressure grouted with cement. Need to audit record to confirm if ABO issued as permit number 9503 authorizes current owner and the modifications made to this crossing are allowed under this ABO. (O. Magana - DWR UCIP)04/20/2017 Crossing appears to be in good condition. (DWR Sutter Yard- AFreitag)11/01/2016 Crossing appears to be in good condition. (DWR Sutter Yard- AFreitag)06/16/2016 Pipe was internally cleaned and camera inspected on 11/19/2015 by Nor-Cal Pipeline Services. 129.5 ft (starting from the WS end) was inspected to get get us through the levee prism but the LS end was never found. Pipe showed no signs of rust or damage.04/14/2016 Inlet structure still filled with soil.04/02/2015 Same as last inspection. Pipe has been selected for internal camera inspection.According to local people, the crossing is functional. The gap between 8-inch and 24-inch pipes is grouted with cement. Inlet structure is filled with soil.07/02/2014 Same as last inspection.12/19/2013 Same as last inspection.07/24/2013 Same as last inspection. FIELD_STRUCT_DESC: 24-inch corrugated metal drainage pipe through the levee, 19 feet below the crown. 8-inch steel pipe sleeved through the 24-inch pipe. Annular space cement grouted. Slide gate at the waterside (WS) toe. Concrete inlet box on the landside (LS). (24-inch pipe [HLM 18.74] authorized under Automatic Board Order (ABO) issued as Permit No. 9503, 1974 - Baird). [Additional Reference(s): DWR Levee Log, 2002. USACE Sacramento O&M Manual 136, March 1960 (HLM 18.74)]. FS Date: 8/5/2019 2:54:00 PM

WS view: overview of slide gate structure

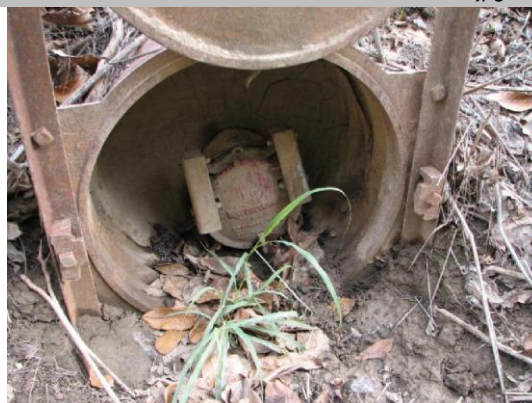
Photo 2 of 3 : UCIP_FA_2019_55611_47441.jpg

DS_ID:17346
FS_ID:55611
EP_NO: 9503
Repair Type: Non-Urgent
Crossing Status: Found
UCIP Comments: 08/05/2019 Crossing has been updated from No Action Needed to Non-Urgent, pipe has been modified from original use. An 8-inch pipe has been sleeved through the 24-inch pipe and gap between pipes pressure grouted with cement. Need to audit record to confirm if ABO issued as permit number 9503 authorizes current owner and the modifications made to this crossing are allowed under this ABO. (O. Magana - DWR UCIP)04/20/2017 Crossing appears to be in good condition. (DWR Sutter Yard- AFreitag)11/01/2016 Crossing appears to be in good condition. (DWR Sutter Yard- AFreitag)06/16/2016 Pipe was internally cleaned and camera inspected on 11/19/2015 by Nor-Cal Pipeline Services. 129.5 ft (starting from the WS end) was inspected to get get us through the levee prism but the LS end was never found. Pipe showed no signs of rust or damage.04/14/2016 Inlet structure still filled with soil.04/02/2015 Same as last inspection. Pipe has been selected for internal camera inspection.According to local people, the crossing is functional. The gap between 8-inch and 24-inch pipes is grouted with cement. Inlet structure is filled with soil.07/02/2014 Same as last inspection.12/19/2013 Same as last inspection.07/24/2013 Same as last inspection.

FIELD_STRUCT_DESC: 24-inch corrugated metal drainage pipe through the levee, 19 feet below the crown. 8-inch steel pipe sleeved through the 24-inch pipe. Annular space cement grouted. Slide gate at the waterside (WS) toe. Concrete inlet box on the landside (LS). (24-inch pipe [HLM 18.74] authorized under Automatic Board Order (ABO) issued as Permit No. 9503, 1974 - Baird). [Additional Reference(s): DWR Levee Log, 2002. USACE Sacramento O&M Manual 136, March 1960 (HLM 18.74)].
FS Date: 8/5/2019 2:54:00 PM

WS view: 8-inch pipe inside 24-inch CMP

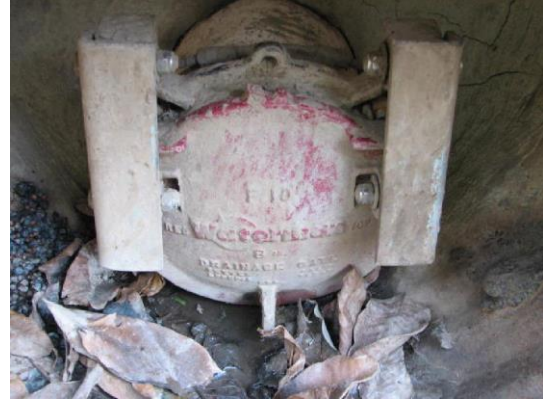
Photo 3 of 3 : UCIP_FA_2019_55611_47440.jpg

DS_ID:17346
FS_ID:55611
EP_NO: 9503
Repair Type: Non-Urgent
Crossing Status: Found
UCIP Comments: 08/05/2019 Crossing has been updated from No Action Needed to Non-Urgent, pipe has been modified from original use. An 8-inch pipe has been sleeved through the 24-inch pipe and gap between pipes pressure grouted with cement. Need to audit record to confirm if ABO issued as permit number 9503 authorizes current owner and the modifications made to this crossing are allowed under this ABO. (O. Magana - DWR UCIP)04/20/2017 Crossing appears to be in good condition. (DWR Sutter Yard- AFreitag)11/01/2016 Crossing appears to be in good condition. (DWR Sutter Yard- AFreitag)06/16/2016 Pipe was internally cleaned and camera inspected on 11/19/2015 by Nor-Cal Pipeline Services. 129.5 ft (starting from the WS end) was inspected to get get us through the levee prism but the LS end was never found. Pipe showed no signs of rust or damage.04/14/2016 Inlet structure still filled with soil.04/02/2015 Same as last inspection. Pipe has been selected for internal camera inspection.According to local people, the crossing is functional. The gap between 8-inch and 24-inch pipes is grouted with cement. Inlet structure is filled with soil.07/02/2014 Same as last inspection.12/19/2013 Same as last inspection.07/24/2013 Same as last inspection.

FIELD_STRUCT_DESC: 24-inch corrugated metal drainage pipe through the levee, 19 feet below the crown. 8-inch steel pipe sleeved through the 24-inch pipe. Annular space cement grouted. Slide gate at the waterside (WS) toe. Concrete inlet box on the landside (LS). (24-inch pipe [HLM 18.74] authorized under Automatic Board Order (ABO) issued as Permit No. 9503, 1974 - Baird). [Additional Reference(s): DWR Levee Log, 2002. USACE Sacramento O&M Manual 136, March 1960 (HLM 18.74)].
FS Date: 8/5/2019 2:54:00 PM

WS view: 8-inch pipe and drain gate

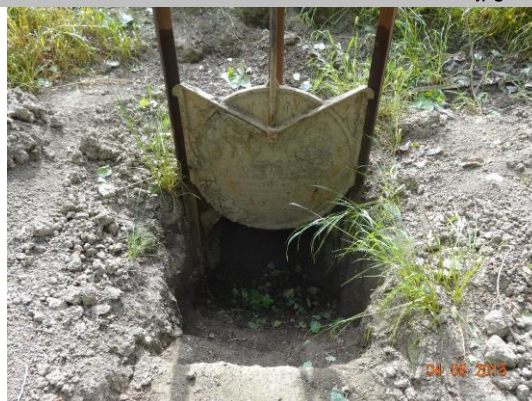
Photo 3 of 3 : UCIP_FA_2019_55616_73781.jpg

Item	DRAFT DWR UCIP LMA Responsibility			39.370031 °	39.370031 °	
				-121.996458 °	-121.996458 °	
DWR ID	17347					
Comment Code						
Inspector Comment						
DS_ID:17347 FS_ID:55616 EP_NO: N/A Repair Type: Non-Urgent Crossing Status: Found UCIP Comments: 08/05/2019 Crossing has been updated from No Action Needed to Non-Urgent due to missing records indicating extent of grout plug through pipe. Only slide gate is visible on the WS. No permit has been identified for this crossing. Need to contact owner to abandon or remove pipe properly according to Title 23 requirements. (O. Magana - DWR UCIP)04/20/2017 Abandoned- plugged. (DWR Sutter Yard- A Freitag)11/01/2016 Abandoned/plugged. (DWR Sutter Yard- A Freitag)06/16/2016 Internal camera inspection was done on 11/19/2015 by Nor-Cal Pipeline Services. Pipe was inspected starting from the WS end and inspected up to the grout plug that is 13.7ft into the pipe. Pipe was then capped and reburied until further abandonment can be achieved.04/02/2015 WS end of pipe was dug up in preparation for internal camera inspection. 07/02/2014 Same as last inspection.12/19/2013 Same as last inspection.07/24/2013 Same as last inspection.12/11/2012 Only steel slide gate structure found on WS. (P. Amatya - DWR UCIP) FIELD_STRUCT_DESC: *ABANDONED* 36-inch corrugated metal drainage pipe through the levee, 21.7 feet below the crown. Slide gate at the waterside (WS) toe. Pipe grouted on the WS end. [Additional Reference(s): DWR Levee Log, 2002. USACE Sacramento O&M Manual 136, March 1960 (HLM 19.24)]. FS Date: 8/5/2019 3:00:00 PM

WS pipe end and screw gate

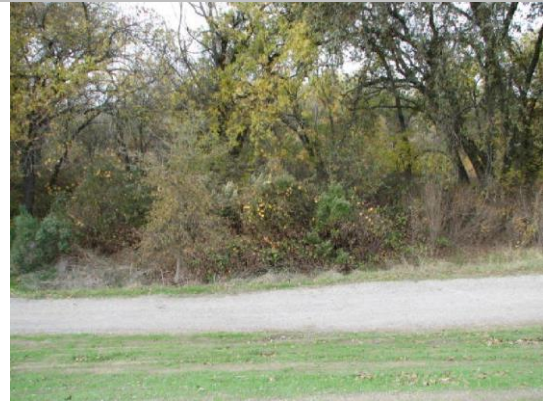
Photo 1 of 3 : UCIP_FA_2019_56037_47449.jpg

Comment Code						
Inspector Comment						
DS_ID:17487 FS_ID:56037 EP_NO: N/A Repair Type: Urgent Crossing Status: Found UCIP Comments: 08/05/2019 Crossing has been upgraded from Non-Urgent to Urgent due to photos taken in 2012 that show deteriorated pipe on the WS. Unable to complete thorough inspection due to dense vegetation on the WS. No permit has been identified authorizing crossing. Crossing has been abandoned, if crossing is no longer used owner will need to coordinate with the CVFPB to remove or abandon according to Title 23 requirements. (O. Magana - DWR UCIP)04/20/2017 Abandoned- needs to be done so properly. (DWR Sutter Yard- A Freitag)11/01/2016 Abandoned.(DWR Sutter Yard- A Freitag)06/03/2016 Abandoned crossing.04/02/2015 Same as last inspection. 07/02/2014 Same as last inspection.12/19/2013 Same as last inspection.07/24/2013 Same as last inspection.12/11/2012 Slide Gate WS not found. An abandoned pump and steel pipe found on WS. A 6 ft x 8 ft concrete distribution box with a CMP found on LS. Box filled with soil. An abandoned crossing. (P. Amatya - DWR UCIP) FIELD_STRUCT_DESC: *ABANDONED* 36-inch corrugated metal drainage pipe through the levee, invert 21.7 feet below the crown. Abandoned pump and steel pipe found on the waterside (WS). 6 foot by 8 foot concrete distribution box with the 36-inch corrugated metal pipe found on the landside (LS). [Additional Reference(s): USACE Sacramento O&M Manual 136, March 1960 (HLM 19.61)]. FS Date: 8/5/2019 3:07:00 PM

WS view: overview
